# Electrical Safety Assessment Report

## TSS-FASHION

Telerchala, Mouchak, Kaliakor, Gazipur, Bangladesh.  
24.0228444 N, 90.3003772 E

Date of Assessment : 14 Oct 2021  
Report Code : 145\_CP\_2021\_1170\_TSS-FASHION\_ESA\_V00  
Report Version : V00\_14 October 2021  
Name of the Assessor : Imtiaz Mahmud  
Assessing Firm :

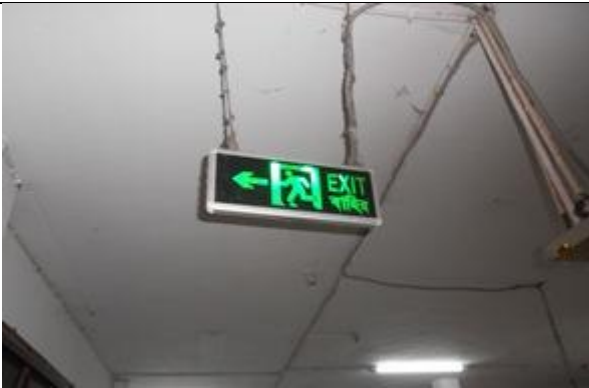
| Observation | Proper backup were not observed. | | |

| Corrective Action | 1. Provide and maintain at least 10 lux illumination at floor level for exit sign.<br>2. Provide alternate / emergency backup for illuminating the exit signs for at least 30 minutes. | | |

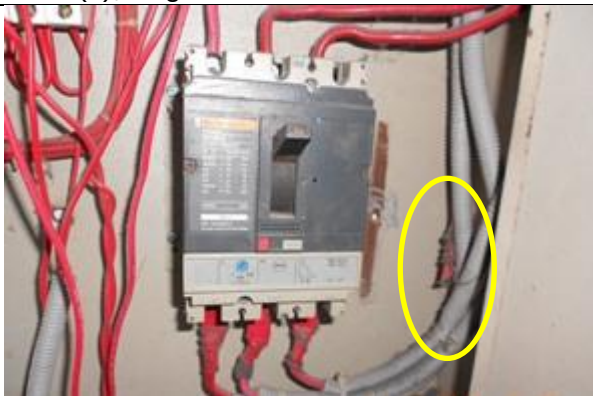
| 31 | Any cable / wire found exposed or open live?<br>Cable ends / sockets have improper connections? | Risk Level | Very High |
| Observation | Exposed / open wires were found. | | |

| Corrective Action | All strands cables at exposed ends should be properly soldered / crimped and insulated. | | |

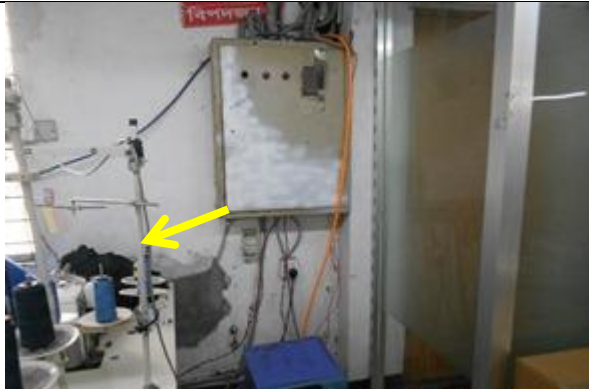
| 37 | Are there any inflammable materials found surrounding electric circuitry at MDBs / SDBs? | Risk Level | High |
| Observation | Inflammable materials found stored surrounding electric circuitry. | | |

| 37 | Are there any inflammable materials found surrounding electric circuitry at MDBs / SDBs? | Risk Level | High |
|---|---|---|---|
| Corrective Action | 1. Remove all the inflammable materials from surrounding of electrical circuitry at MDBs/SDBs<br>2. Ensure that all electric circuitry clean of inflammable materials.<br>3. Conduct periodic maintenance and maintain the records. | | |
