গণপ্রজাতন্ত্রী বাংলাদেশ সরকার
শ্রম ও কর্মসংস্থান মন্ত্রণালয়
কলকারখানা ও প্রতিষ্ঠান পরিদর্শন অধিদপ্তর

ক্যাপ পর্যবেক্ষণের তথ্য

কারখানার নাম	হর্নবিল এম্পায়ার লিঃ
ঠিকানা	S A plot # 310, Baimail, P.O. - Quasem Cotton Mills, Konabari, Gazipur
কারখানার কোড	GZP148
কালার কোড	
মূল্যায়নের ধরণ: কাঠামোগত মূল্যায়ন	পর্যবেক্ষণের তারিখ: ১৯-০২-২০২৩
১. পর্যবেক্ষণ

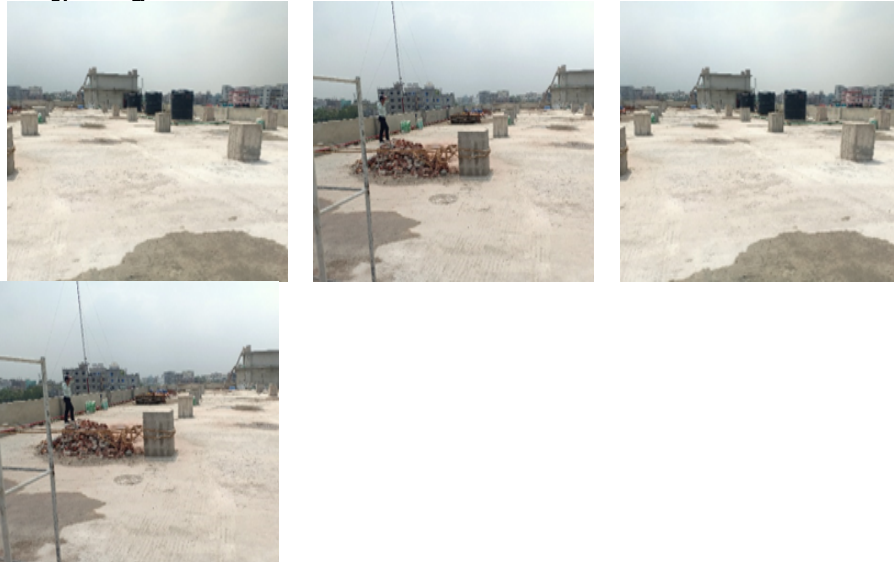
সংযুক্তিসমূহ (৪)

পরিদর্শন পর্যবেক্ষণ	Corroded Re-bars
কাপ আইটেম ক্যাটাগরি

কার্যক্রম	Exposed rebar needs to be covered by lean graded concrete as per direction of building engineer.
সুপারিশের তথ্যসূত্র	
কারখানার কার্যক্রম	We has engaged contractor to cover the exposed rebar with lean graded concrete as per direction of their consultant.
অগ্রাধিকার	প্রযোজ্য নয়
চূড়ান্ত সময়সীমা	৩১-০৫-২০১৭
সংশোধিত সময়সীমা	০১-০১-১৯৭০
অগ্রগতির অবস্থা	সংশোধিত
মন্তব্য	Previous timeline : 01/02/2017 Final Timeline: 31/05/2017 Not taken any action regarding this issue but factory agreed to complete the issue within timeline. June 28, 2020: Exposed rebars are covered with concrete. But several water poundings were found on the rooftop. 11.10.2020: There is no exposed rebar has been observed during CVV. 16.08.2021: No exposed rebars were observed. 23.08.2022: Column exposed rebar on roof top not found. They already covered all exposed rebar by concrete. 19.02.2023: Column exposed rebar on roof top not found. They already covered all exposed rebar by concrete.
