গণপ্রজাতন্ত্রী বাংলাদেশ সরকার  
শ্রম ও কর্মসংস্থান মন্ত্রণালয়  
কলকারখানা ও প্রতিষ্ঠান পরিদর্শন অধিদপ্তর

ক্যাপ পর্যবেক্ষণের তথ্য

কারখানার নাম	ক্রস লাইন ওভেন এ্যাপারেলস লিঃ
ঠিকানা	Sharifpur, Haricne (Left side) National University, Gazipur Sadar, Gazipur
কারখানার কোড	GZP078
কালার কোড	
মূল্যায়নের ধরণ: <a href="#">কাঠামোগত মূল্যায়ন</a>	পর্যবেক্ষণের তারিখ: ৩০-০৫-২০২২
১. পর্যবেক্ষণ

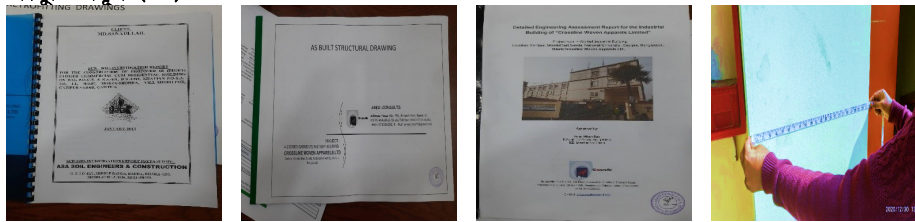
### সংযুক্তিসমূহ ( ৪ )

পরিদর্শন পর্যবেক্ষণ	Existing structure do not match with Structural Drawing. Corner column dimension is measured 15"x15" on field whereas structural drawing shows 18"x18" corner column. Furthermore, the building have cantilevers on three sides in contrary to the drawing.
কাপ আইটেম কাটাগরি

কার্যক্রম	Building Engineer to survey column locations and compare with structural drawings. Updated drawings to be prepared showing the correct as constructed layout.
সুপারিশের তথ্যসূত্র	
কারখানার কার্যক্রম	We will be assign with design and consultant firm and they will complete
অগ্রাধিকার	৬ মাস
চূড়ান্ত সময়সীমা	০৩-০২-২০১৭
সংশোধিত সময়সীমা	০১-০১-১৯৭০
অগ্রগতির অবস্থা	সংশোধিত
মন্তব্য	30.12.2020: They have done retrofitting taking ACCORD/RSC's permission. This NC, incorrect information of having 15"x15" and drawing showing 18"x18" has been corrected. Since they have done retrofitting their column sizes now upgraded to 23"x23" ( 24"x24" including the plaster ) . But they didn't submit the drawings to DIFE. According to ACCORD/RSC, they need to do another soil test and they have done it too but they will receive the test report later. They have done maximum of their work according to ACCORD/RSC standards. 30-05-2022 ( CCVV ): They have done retrofitting taking ACCORD/RSC's permission. As they are a member of ACCORD/RSC ( ID: 10055 ), they have done DEA, design drawings and also load plans. But they didn't submit any of the documents to DIFE. According to ACCORD/RSC, they need to do another soil test and they have done it too but they will receive the test report later. They have done maximum of their work according to ACCORD/RSC standards.
